**Flood Control Project Maintenance
Levee Inspections**
LMA District Cover Sheet
Spring 2017 Levee Inspection Results

Reclamation District No. 2063 Crows Landing

Spring 2017 Levee Inspection Results

Waterway			Bank	Unit Miles
Unit No. 01 San Joaquin River			Right	10.44
	Spring (March - May)	Summer (June - August)	(September - November) Fall	Winter (December - February)
Unit Maintenance Rating (Fall Only)				
Date of Inspection	4/11/2017 - 4/11/2017			
DWR Inspector	Richard Willoughby			
Accompanied By

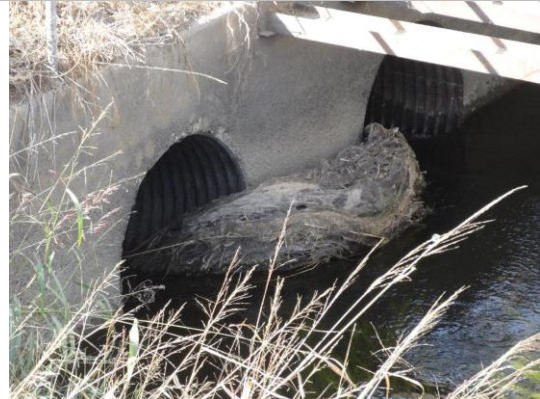
Photo 3 of 3 : UCIP_SP_2017_24636_43963.jpg

LS view: drainage pipes under walkway in drainage ditch.

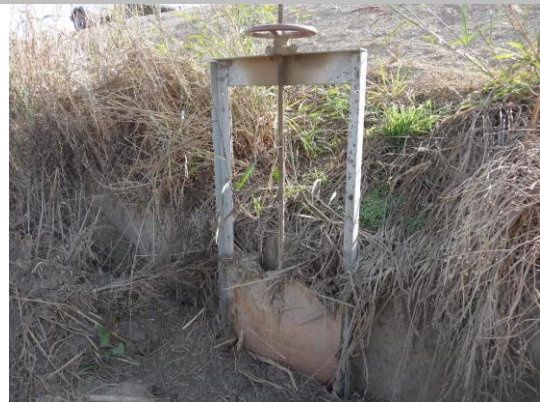
Photo 1 of 2 : UCIP_SP_2017_24638_43967.jpg

LM Start	9.05	Rating **	A/W	Issue No.	90
LM End	9.05	Issue Type +	Ma	Location *	LS
Category	Supplemental			GPS Latitude/Longitude	
				Start	End
Item	DWR UCIP LMA Responsibility			37.390804 °	37.390804 °
				-120.966394 °	-120.966394 °
DWR ID					
Comment Code					
Inspector Comment					
FS_ID:24638 DS_ID:22114 EP_NO: N/A Repair Type: No Action Needed Crossing Status: Found UCIP Comments: Flap gate and concrete "U" headwall not visible due to dense vegetation on waterside. FIELD_STRUCT_DESC: 24-inch CM pipe through levee 12.0 feet below crown. Flap gate and concrete "U" headwall on waterward end. Grouted spillway 7 feet in length on waterward end. Slide gate on pipe end and concrete headwall on landside end. Installed by USCE 1961. O&M Manual SJR 006, Sept. 1961. FS Date: 11/6/2013

WS view: concrete headwall on levee end. Slide gate on pipe end.

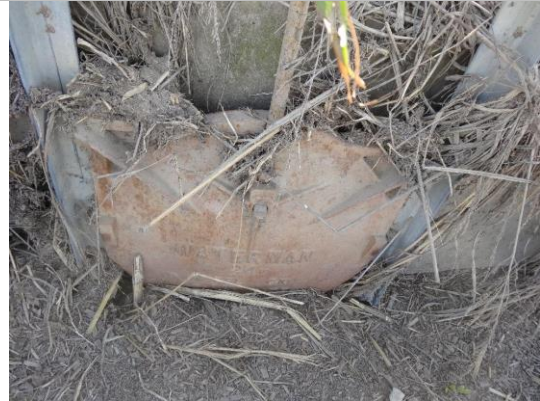
Photo 2 of 2 : UCIP_SP_2017_24638_43966.jpg

WS view: close view of slide gate on pipe end.

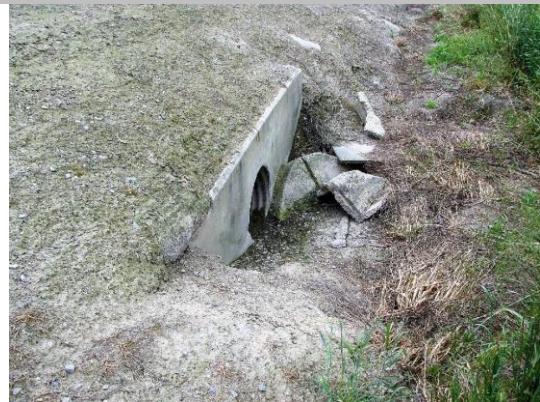
Photo 1 of 3 : UCIP_SP_2017_51825_77044.jpg

LM Start	9.50	Rating **	A/W	Issue No.	91
LM End	9.50	Issue Type +	Ma	Location *	LS
Category	Supplemental			GPS Latitude/Longitude	
				Start	End
Item	DWR UCIP LMA Responsibility			37.390682 °	37.390682 °
				-120.958287 °	-120.958287 °
DWR ID					
Comment Code					
Inspector Comment					
FS_ID:51825 DS_ID:22115 EP_NO: N/A Repair Type: No Action Needed Crossing Status: Found UCIP Comments: 04/11/2017 LS inlet has been cleared, as per DWR inspector Richard Willoughby. (K. Fazel - UCIP)11/06/2013 Landside inlet blocked by plywood. (P. Amatya - DWR) FIELD_STRUCT_DESC: 24-inch CM pipe through the levee 5.6 feet below the crown. Flap gate and concrete "U" headwall on the waterward end. Concrete headwall on the landward end. Installed by USCE 1961. O&M Manual SJR 006, Sept. 1961. FS Date: 4/11/2017

LS inlet as of 4/11/2017 levee inspection. Photo courtesy of DWR inspector Richard Willoughby.

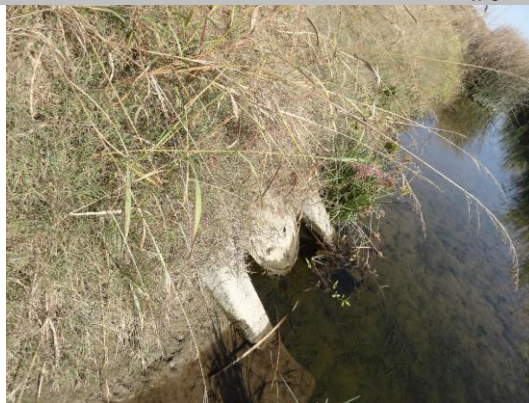
Photo 2 of 3 : UCIP_SP_2017_51825_43983.jpg

WS view: U type headwall and flap gate visible on the bank of the water channel.

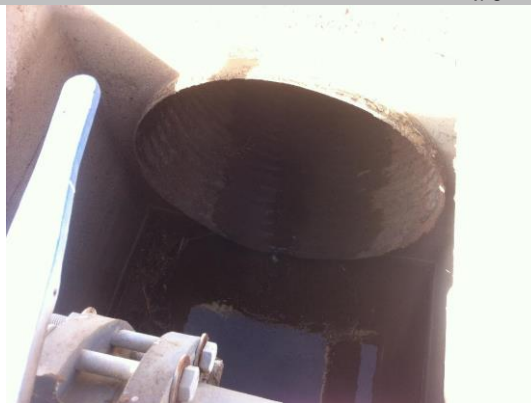
Photo 1 of 3 : UCIP_SP_2017_24644_43986.jpg

FS_ID:24644
DS_ID:22116
EP_NO: N/A
Repair Type: No Action Needed
Crossing Status: Found
UCIP Comments: - not very old structure.
FIELD_STRUCT_DESC: 48-inch CM pipe through the levee and across drain ditch on the waterward side 6.0 feet below the crown. Slide gate and concrete box on the waterside end. Concrete box on the landward end. Installed by USCE 1961. O&M Manual SJR 006, Sept. 1961.
FS Date: 11/6/2013

WS view: CM pipe on outlet concrete box.

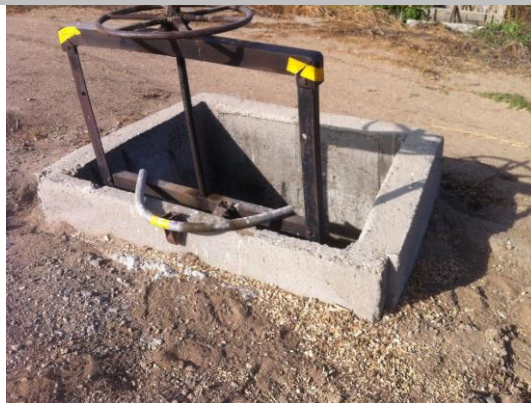
Photo 2 of 3 : UCIP_SP_2017_24644_43985.jpg

LS view: CM pipe with slide gate on inlet concrete box.

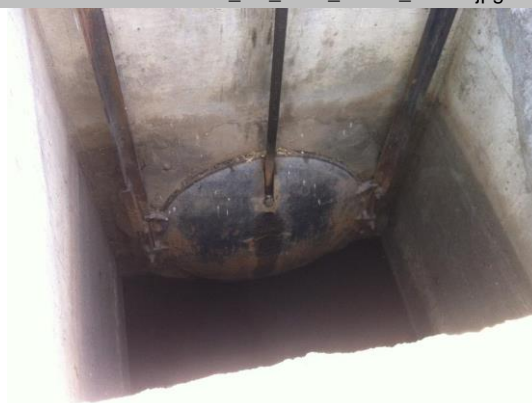
Photo 3 of 3 : UCIP_SP_2017_24644_43984.jpg

LS view: inside view of slide gate in concrete box.

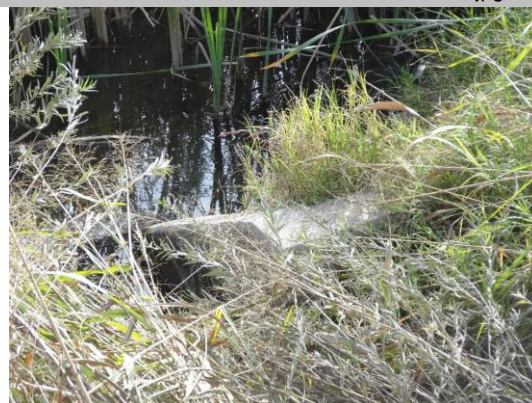
Photo 1 of 2 : UCIP_SP_2017_24645_43988.jpg

LM Start	9.95	Rating **	M	Issue No.	93
LM End	9.95	Issue Type +	Ma	Location *	LS
Category	Supplemental			GPS Latitude/Longitude	
				Start	End
Item	DWR UCIP LMA Responsibility			37.390572 °	37.390572 °
				-120.950156 °	-120.950156 °
DWR ID					
Comment Code					
Inspector Comment					
FS_ID:24645 DS_ID:22117 EP_NO: N/A Repair Type: Non-Urgent Crossing Status: Found UCIP Comments: - waterside not accessible.- partially blocked inlet opening on landside. FIELD_STRUCT_DESC: 24-inch CM pipe through the levee 4.6 feet below the crown. Flap gate and concrete "U" headwall on the waterward end. Concrete headwall on landward end. Installed by USCE 1961. O&M Manual SJR 006, Sept. 1961. FS Date: 11/6/2013

WS view: concrete U type headwall on channel bank. Not accessible.

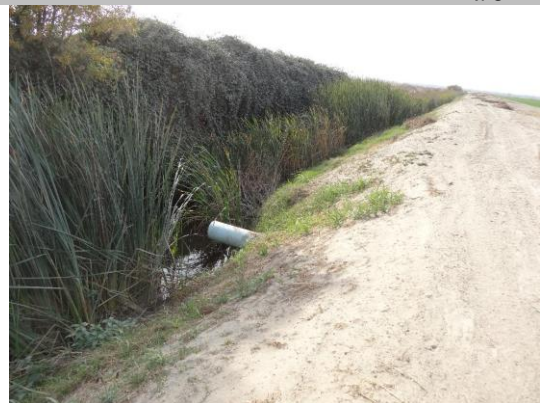
Photo 1 of 3 : UCIP_SP_2017_50221_43990.jpg

LM Start	10.20	Rating **	U	Issue No.	94
LM End	10.20	Issue Type +	En	Location *	LS
Category	Supplemental			GPS Latitude/Longitude	
				Start	End
Item	DWR UCIP Field Study			37.390517 °	37.390517 °
				-120.945659 °	-120.945659 °
DWR ID					
Comment Code					
Inspector Comment					
FS_ID:50221 DS_ID:22074 EP_NO: 11631 Repair Type: Urgent Crossing Status: Found UCIP Comments: 08/23/2016 Same as last inspection. Recommend LMA contact owner to bring crossing into compliance per Title 23. (K. Fazel - UCIP)11/06/2013 Pipe opens on both sides of the levee. (P. Amatya - DWR) FIELD_STRUCT_DESC: 16-inch polyvinyl chloride (PVC) drainage pipe through the levee, 3.5 feet below the crown. Pipe open on both sides of the levee. This crossing was field discovered. FS Date: 8/23/2016

WS view: PVC pipe with open end on levee slope.

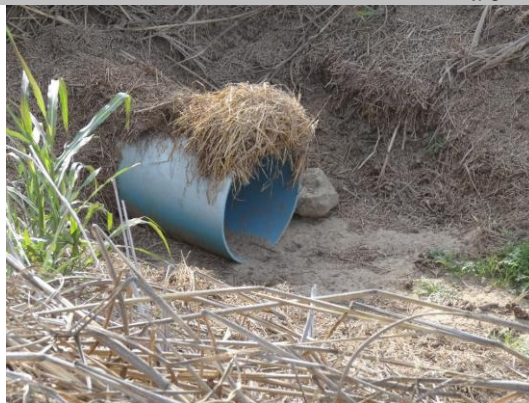
Photo 2 of 3 : UCIP_SP_2017_50221_43989.jpg

LS view: PVC pipe with open end on levee toe.

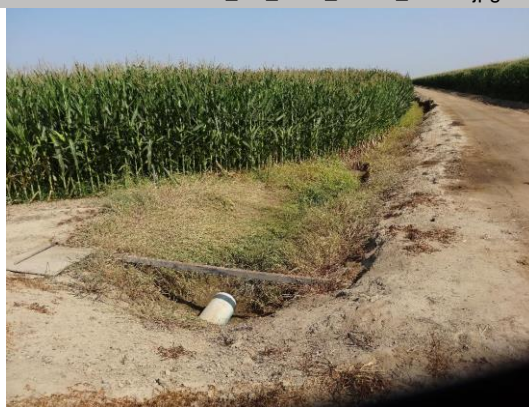
Photo 3 of 3 : UCIP_SP_2017_50221_76005.jpg

LS view of crossing

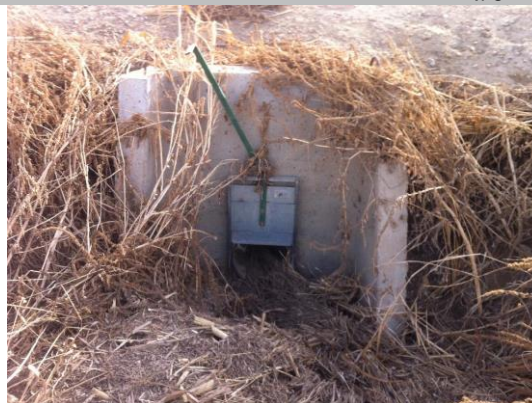
Photo 1 of 3 : UCIP_SP_2017_50222_43993.jpg

FS_ID:50222
DS_ID:24731
EP_NO: N/A
Repair Type: Non-Urgent
Crossing Status: Found
UCIP Comments: 08/23/2016 Same as last inspection. Pipe looks to be relatively newer than 1976. Appears there is no permit for this newer PVC pipe so recommend LMA contact owner to bring crossing into compliance with Title 23. Crossing has been upgraded from No Action Needed to Non-Urgent. (K. Fazel - UCIP)11/05/2013: Pipe not visible on waterside. Dense vegetation on waterside. (P. Amaty - DWR)
FIELD_STRUCT_DESC: 8-inch polyvinyl chloride (PVC) drainpipe through the levee, 4 feet below the crown. Pipe's material is PVC not steel as per Permit No. 11631. Metal slide gate in a "U"-type concrete headwall on the landside (LS). (Permit No. 11631, 1976 - Barcellos).
FS Date: 8/23/2016

LS view: U type concrete headwall, slide gate, and pipe on levee toe.

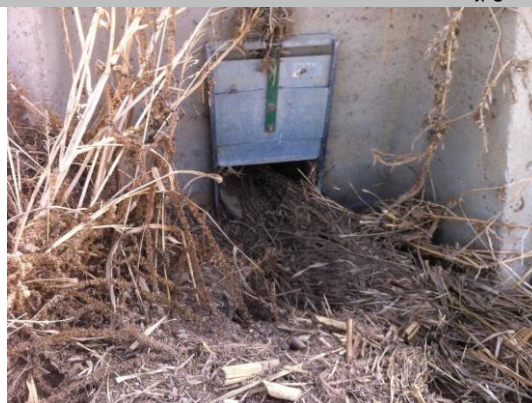
Photo 2 of 3 : UCIP_SP_2017_50222_43992.jpg

LS view: closer view of U type concrete headwall, slide gate, and pipe on levee toe.
